检测报告 Test Report

报告编号 A2200142161101001E

| Sample Name | Converter Grid-Connect Inverter |
| 型号 | J1-Hybrid 3kW |

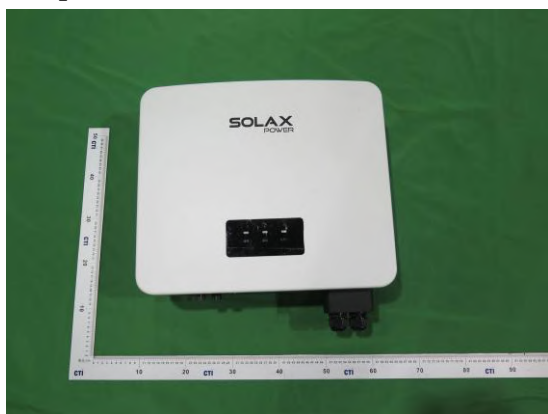
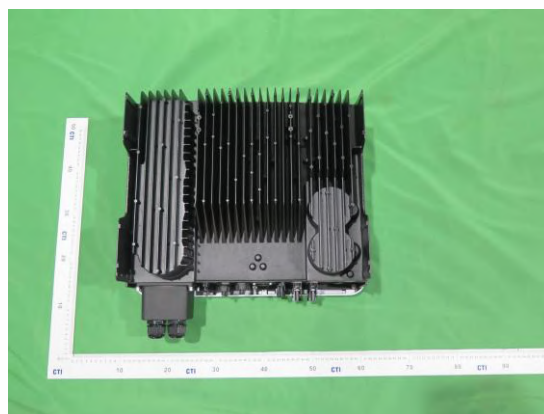
Sample Photo(s)

| 样品编号 Sample No. | 样品名称 Sample Name | 样品型号 Type | 样品数量 Quantity |
|---|---|---|---|
| A2200142161101001 | 单相储能并网光伏逆变器 Converter Grid-Connect Inverter | J1-Hybrid 3kW | 1pc |

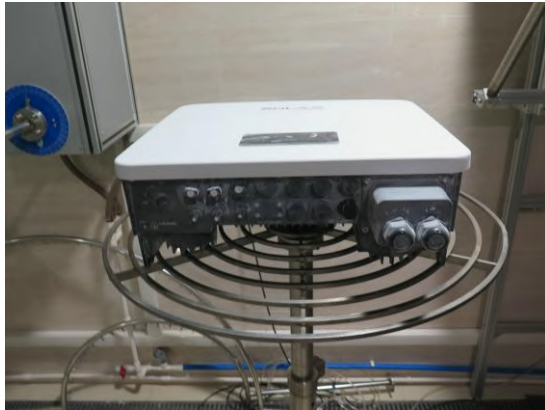
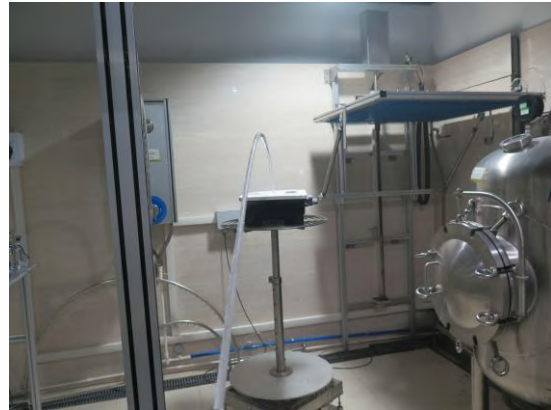
Test Photo(s)

Water flow rate: 12.5L/min

Distance from sample surface to nozzle: 2.5m

Diameter of the nozzle: 6.3mm

The rotation speed of the turntable: 1rpm

Test duration: 3min

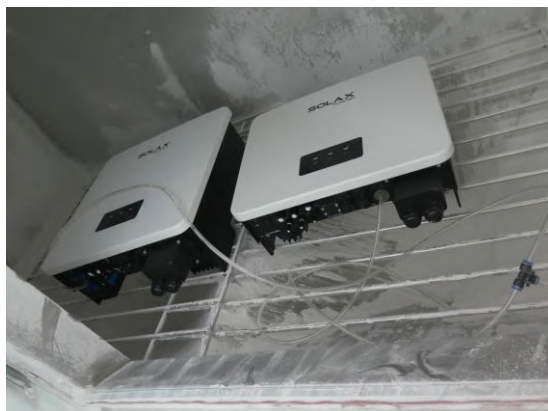
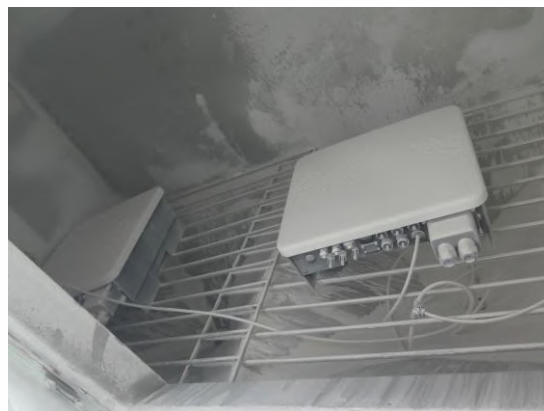
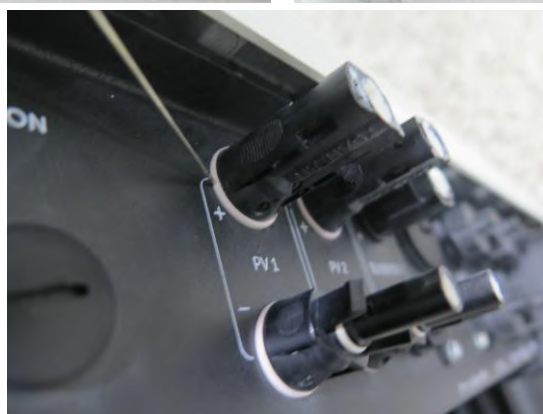
Test Photo(s)

The test probe of 1mm diameter is pushed against any opening of the sample with force of 1 N;

Set the sample in the dust chamber, the pressure inside the enclosure is maintained below the surrounding atmospheric pressure by a vacuum pump (40~60 times of the shell volume per hour; the differential pressure between the containment and the atmosphere: $\leq 2\text{ kPa}$) The talcum powder to be used is 2 kg/m^3 of the test chamber volume;

Test duration: 2 hours.

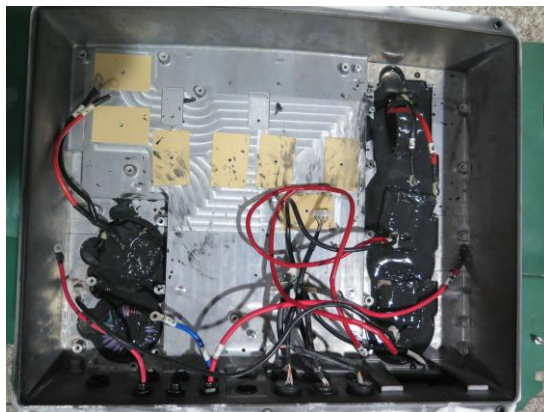
Sample Photo(s) after the test

| 样品编号 Sample No. | 测试结果 Test Result(s) |
|---|--|
| A2200142161101001 | 测试后样品内部未见明显的灰尘沉积，直径 1mm 探针无法进入样品内部金属带电部位，IP6X 测试通过。 No obvious dust was observed in the sample by visual inspection after test. Test probe can't enter the sample. The sample passed the IP6X test. |
