## Test Report

Report No. A2230120683101

Sample Name Lithium ion Rechargeable Battery Module

No.	Test Item
1	IPX5
2	IP6X

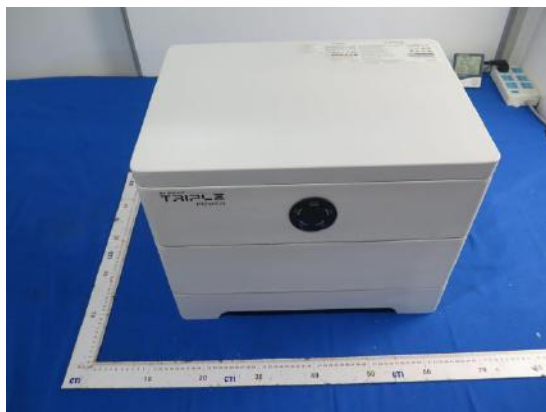
A2230120683101001

**Sample Photo(s)**

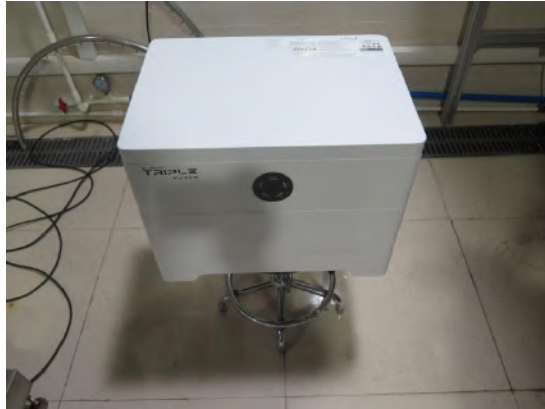
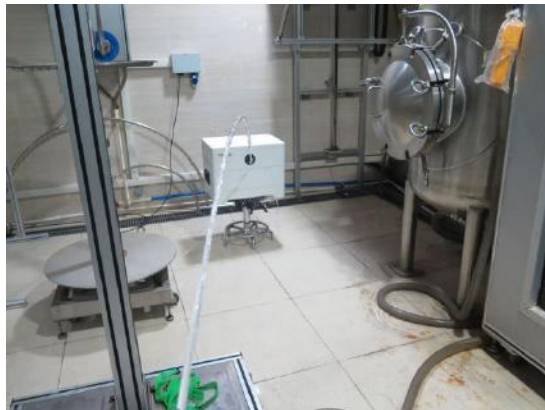
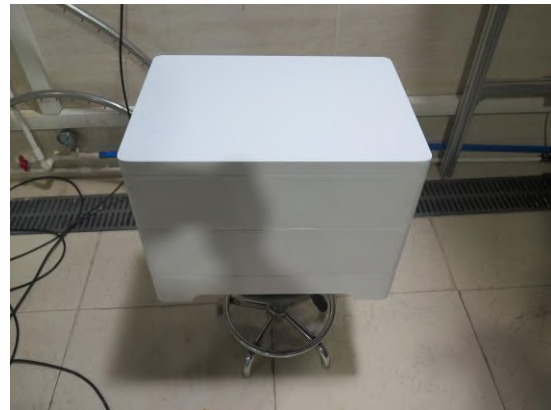
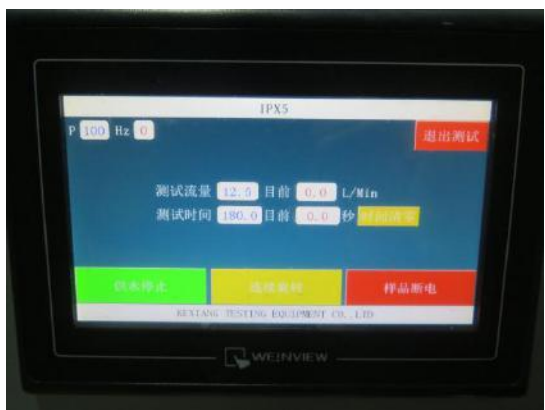
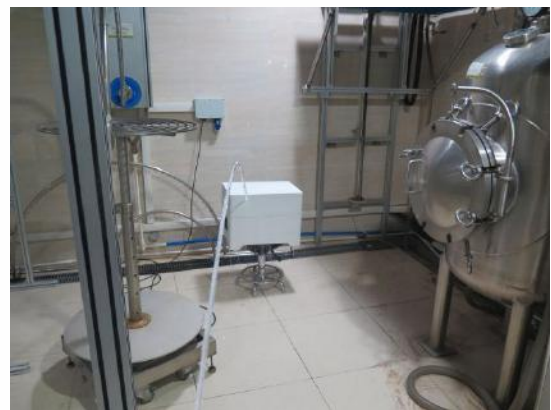
### Test Photo(s)

**Test Item1: IPX5****1. Test Equipment**

Water flow rate: 12.5L/min

Distance from sample surface to nozzle: 2.5m

Diameter of the nozzle: 6.3mm

The rotation speed of the turntable: 1rpm

Test duration: 3min

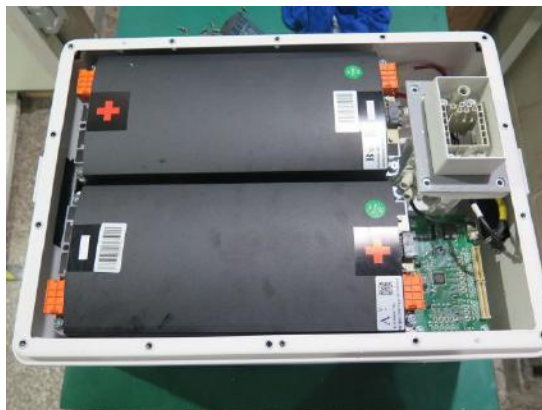
Sample No.	Test Result(s)
A2230120683101001	After the test, there was no water entered into sample by visual inspect, the sample passed the IPX5 test.
A2230120683101002	After the test, there was no water entered into sample by visual inspect, the sample passed the IPX5 test.

## Sample Photo(s) after the test

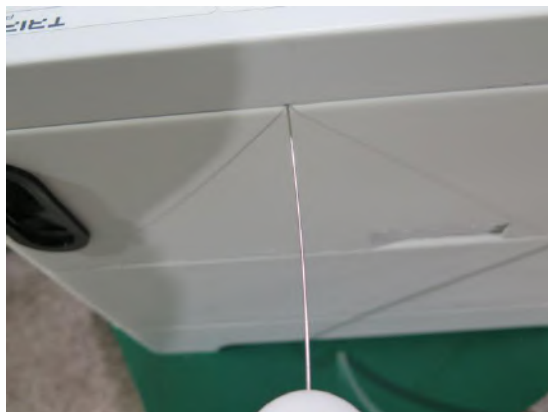
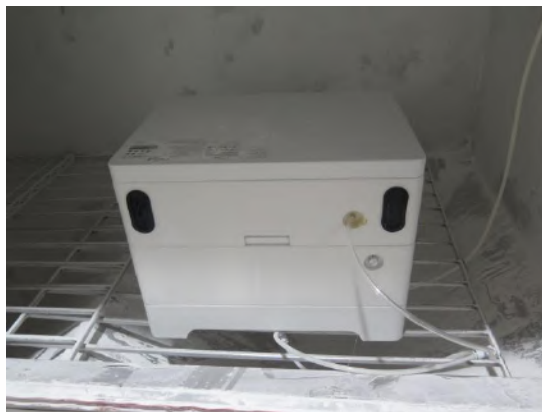
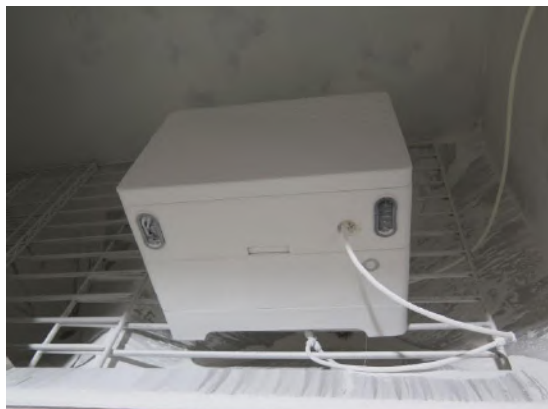
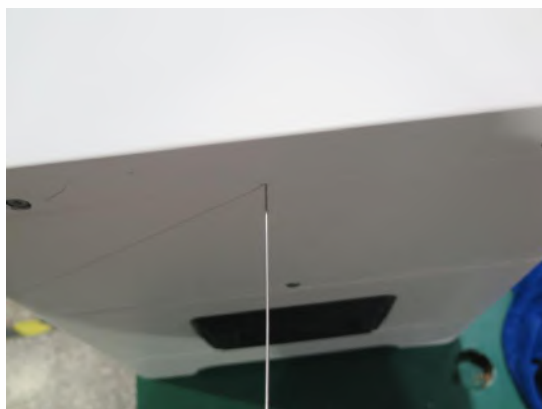
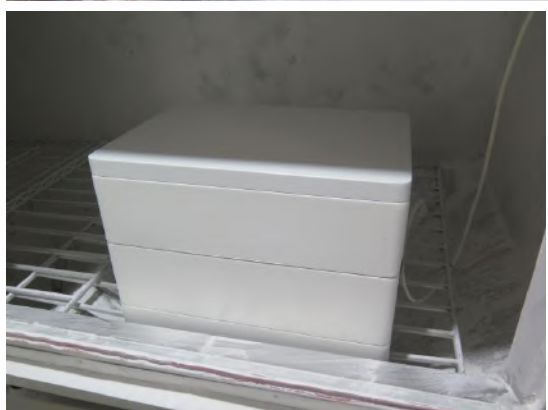
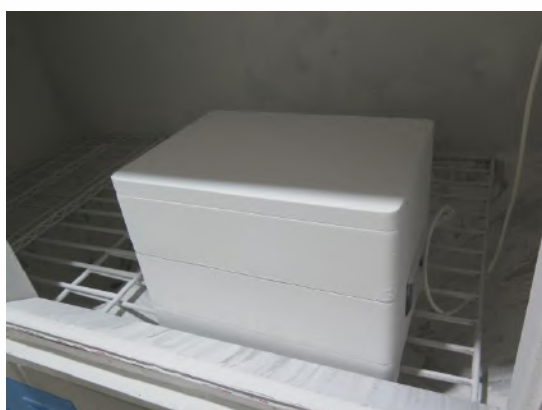
## Test Photo(s)

**Test Item2: IP6X****1. Test Equipment**

The test probe of 1mm diameter is pushed against any opening of the sample with force of 1 N;

Set the sample in the dust chamber, the pressure inside the enclosure is maintained below the surrounding atmospheric pressure by a vacuum pump (40~60 times of the shell volume per hour; the differential pressure between the containment and the atmosphere:  $\leq 2\text{kPa}$ ) The talcum powder to be used is 2 kg/m<sup>3</sup> of the test chamber volume;

Test duration: 8 hours.

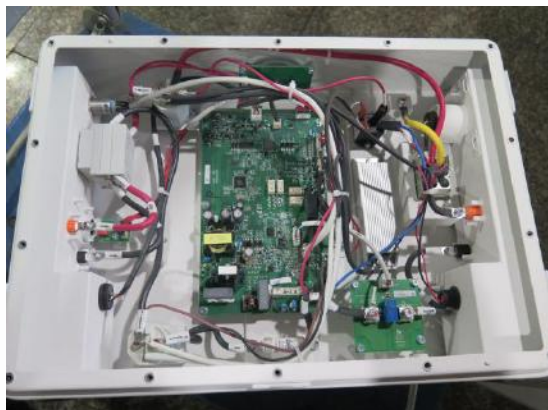
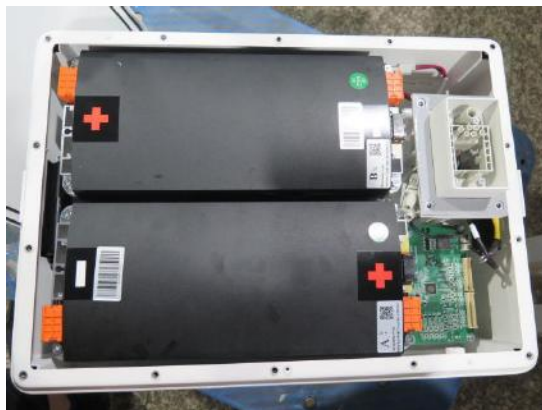
Sample No.	Test Result(s)
A2230120683101001	No obvious dust was observed in the sample by visual inspection after test. Test probe can't enter the sample. The sample passed the IP6X test.
A2230120683101002	No obvious dust was observed in the sample by visual inspection after test. Test probe can't enter the sample. The sample passed the IP6X test.

## Sample Photo(s) after the test
